Casing Wear & Damage Recognition

The following examples have been put together by Bandvulc Tyres Ltd of typical wear & damage seen on tyres together with the adjudication given to the defects; the list is not exhaustive and should only be used as a guide.

Tyre Tread Wear as per “Categorisation of Defects on Road Vehicles”

Casing Damage Recognition as per “Categorisation of Defects on Road Vehicles” Extract from VOSA Testing Standards Enquiry

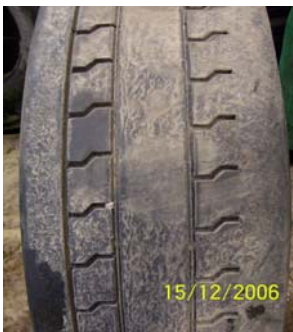
Depth of tread is greater than 1mm throughout the circumference and covers ¾ of the tread width Tyre legal

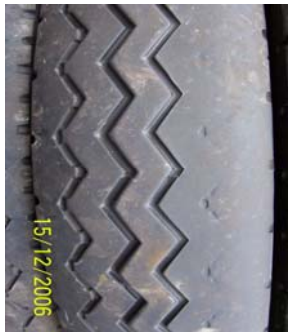
Remaining legal tread pattern less than ¾ of the tread width Tyre illegal

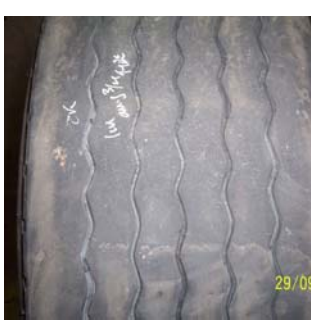
Flat Spot 1mm or more tread 1mm or more of tread depth in any ¾ of the tread area. Tyre Legal

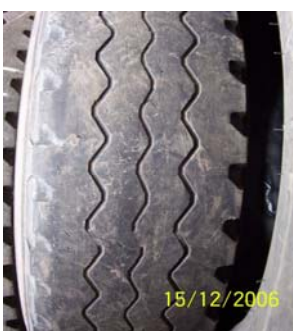
Depth of tread is greater than 1mm throughout the circumference and covers ¾ of the tread width Tyre legal

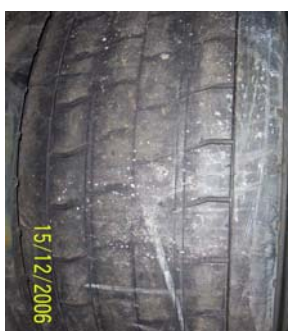
Tread remaining less than 1mm centre of tread, therefore, legal tread pattern less than ¾ of the tread width Tyre illegal

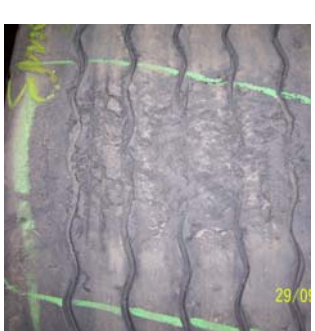
Flat Spot less than 1mm tread Less than 1mm of tread depth in any ¾ of the tread area. Tyre illegal

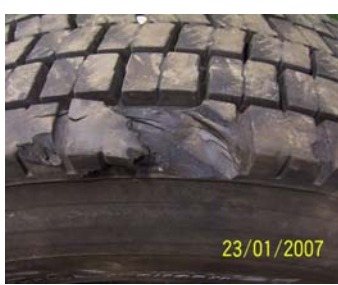
Tread Damage (Rubber Only) 150mm x 45mm area of tread torn from the tread shoulder, no exposed cords PASS AND ADVISE

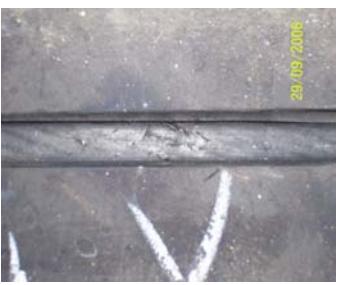
Belt ply cord exposed Regroove too deep, belt ply cords are exposed. FAIL & REMOVE TYRE Belt ply cord can be seen but not exposed PASS AND ADVISE

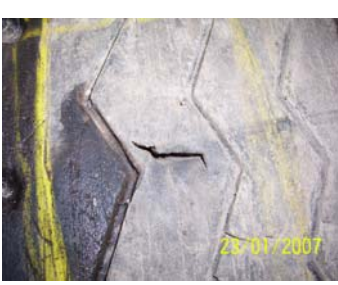
25mm cut to tread Inspection with simple blunt probe, unable to ascertain if cords or foreign object detected. PASS AND ADVISE

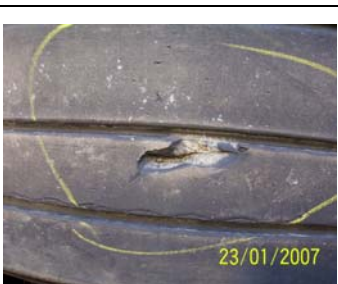
30mm cut to tread (Rubber Only) Cut to tread investigated with blunt probe, no exposed or damaged cords PASS AND ADVISE

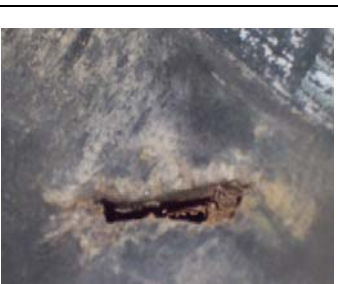
15mm cut to tread Investigation with probe measured depth of cut @ 18mm deep, rust and foreign object material visible within the damage. FAIL & REMOVE TYRE

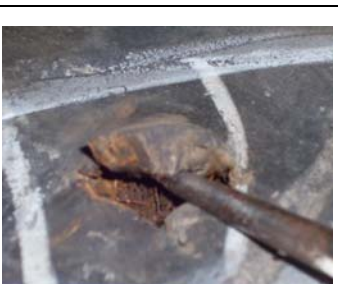
25mm rubber flap, cut to cords Investigation with probe reveals obvious corrosion/damage to cords FAIL & REMOVE TYRE

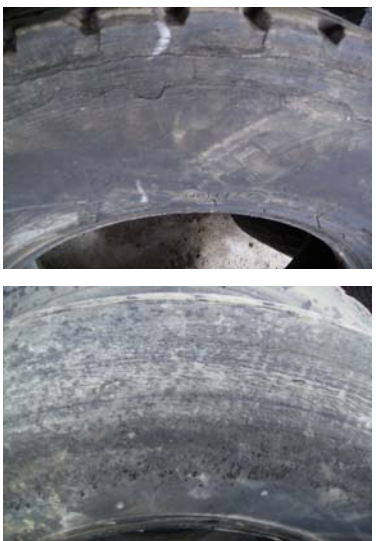
Heavy curbing Sidewall lettering completely removed from sidewall. Minimum requirement = size, load and speed. POSSIBLE = DELAYED PROHIBITION NOTICE CAUTION SHOULD BE EXERCISED CONCERNING EXTENT OF SIDEWALL DAMAGE TURN TYRE ON RIM OR REMOVE TO LESS AGGRESSIVE POSITION, E.G. OFFSIDE OF VEHICLE

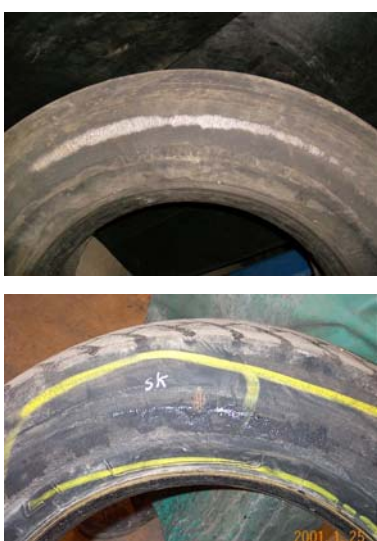
Exposed Body Plies (Cord(s)) Excessive curbing resulting in exposed / damaged cords. FAIL & REMOVE TYRE
